Shift Right drive (9-3-2022)

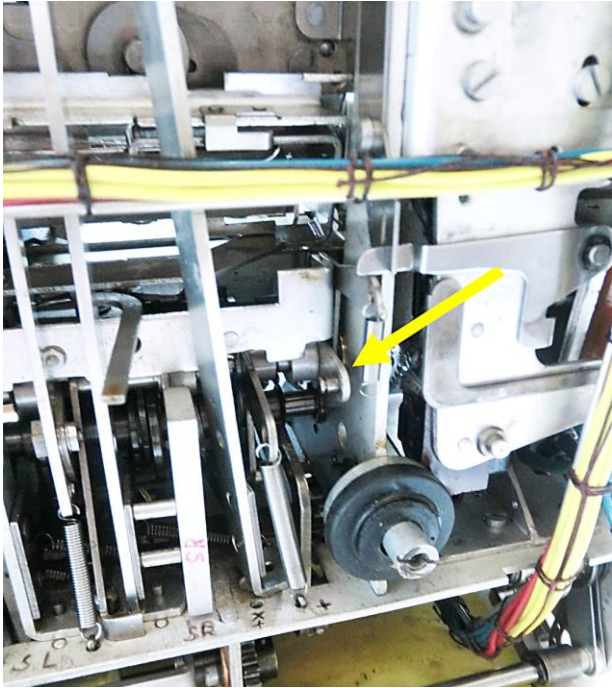
Photo-1

The steel shaft shown in the left photo connects the power source (photo-1) to the mechanism which moves Reg-I (photo-2).

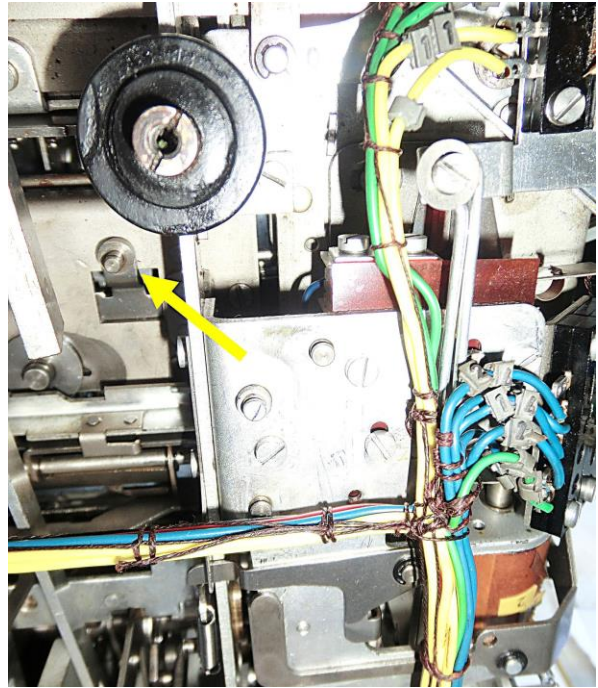
Photo-2

Reg-I is hold in discrete positions by a kind of steel comb and a corresponding mechanism on the bottom of Reg-I. Probably wear in the driving mechanism was the cause of Reg-I just not being driven far enough to the right to reliably snap into the next slot after a Shift-Right. As a consequence during division the machine sometimes got stuck in the middle of the process.
